Debris/Ice/TPS Assessment and Integrated Photographic Analysis of Shuttle Mission STS-89

**DEBRIS/ICE/TPS ASSESSMENT
AND
INTEGRATED PHOTOGRAPHIC ANALYSIS
OF
SHUTTLE MISSION STS-89**

22 January 1998

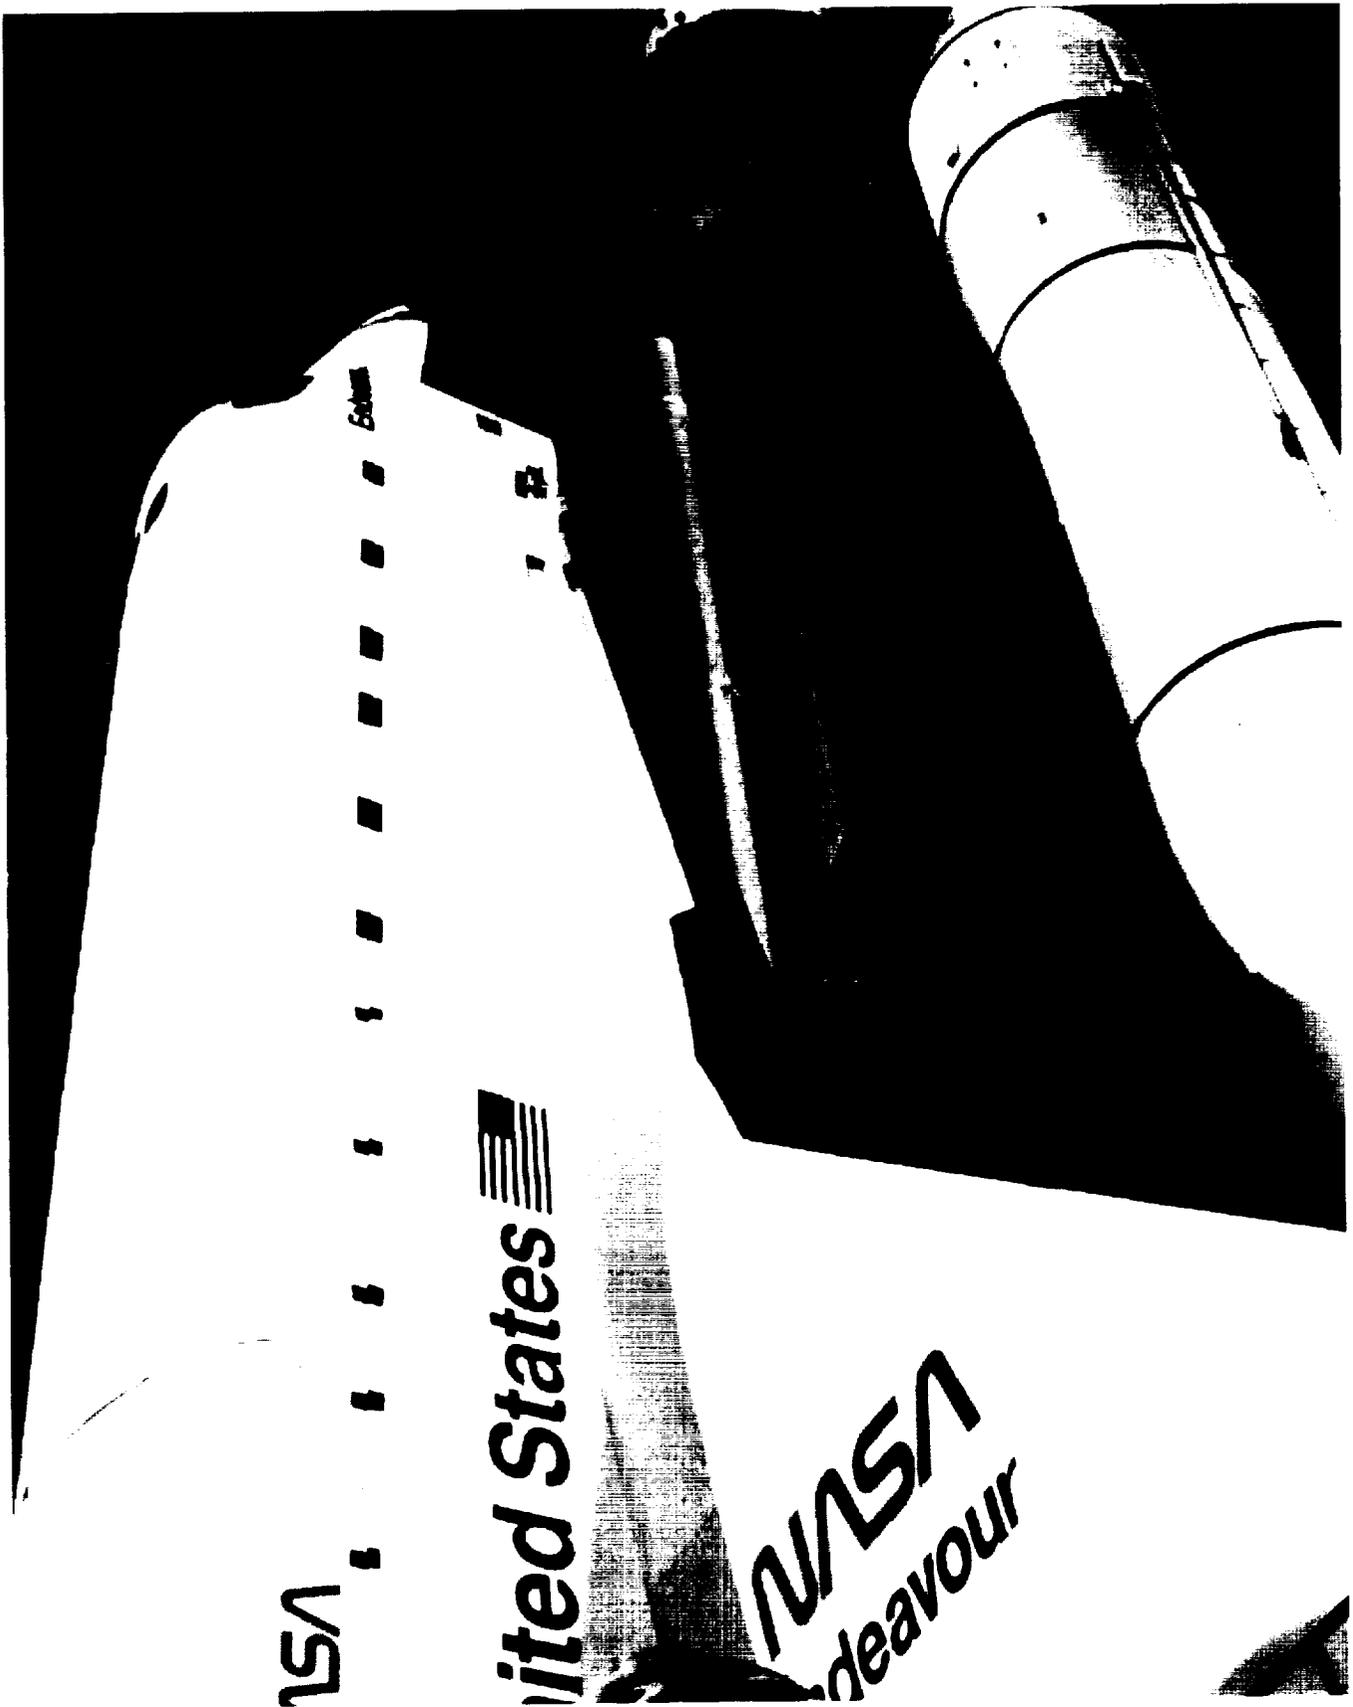
Photo 2: STS-89 Ready for Launch

OV-105 Endeavour (12th flight), ET-90 (LWT 83), and BI-093 SRB's. The Final Inspection Team observed very light condensate, but no ice or frost accumulations, on the LH2 tank acreage. TPS surface temperatures averaged 62 degrees F.

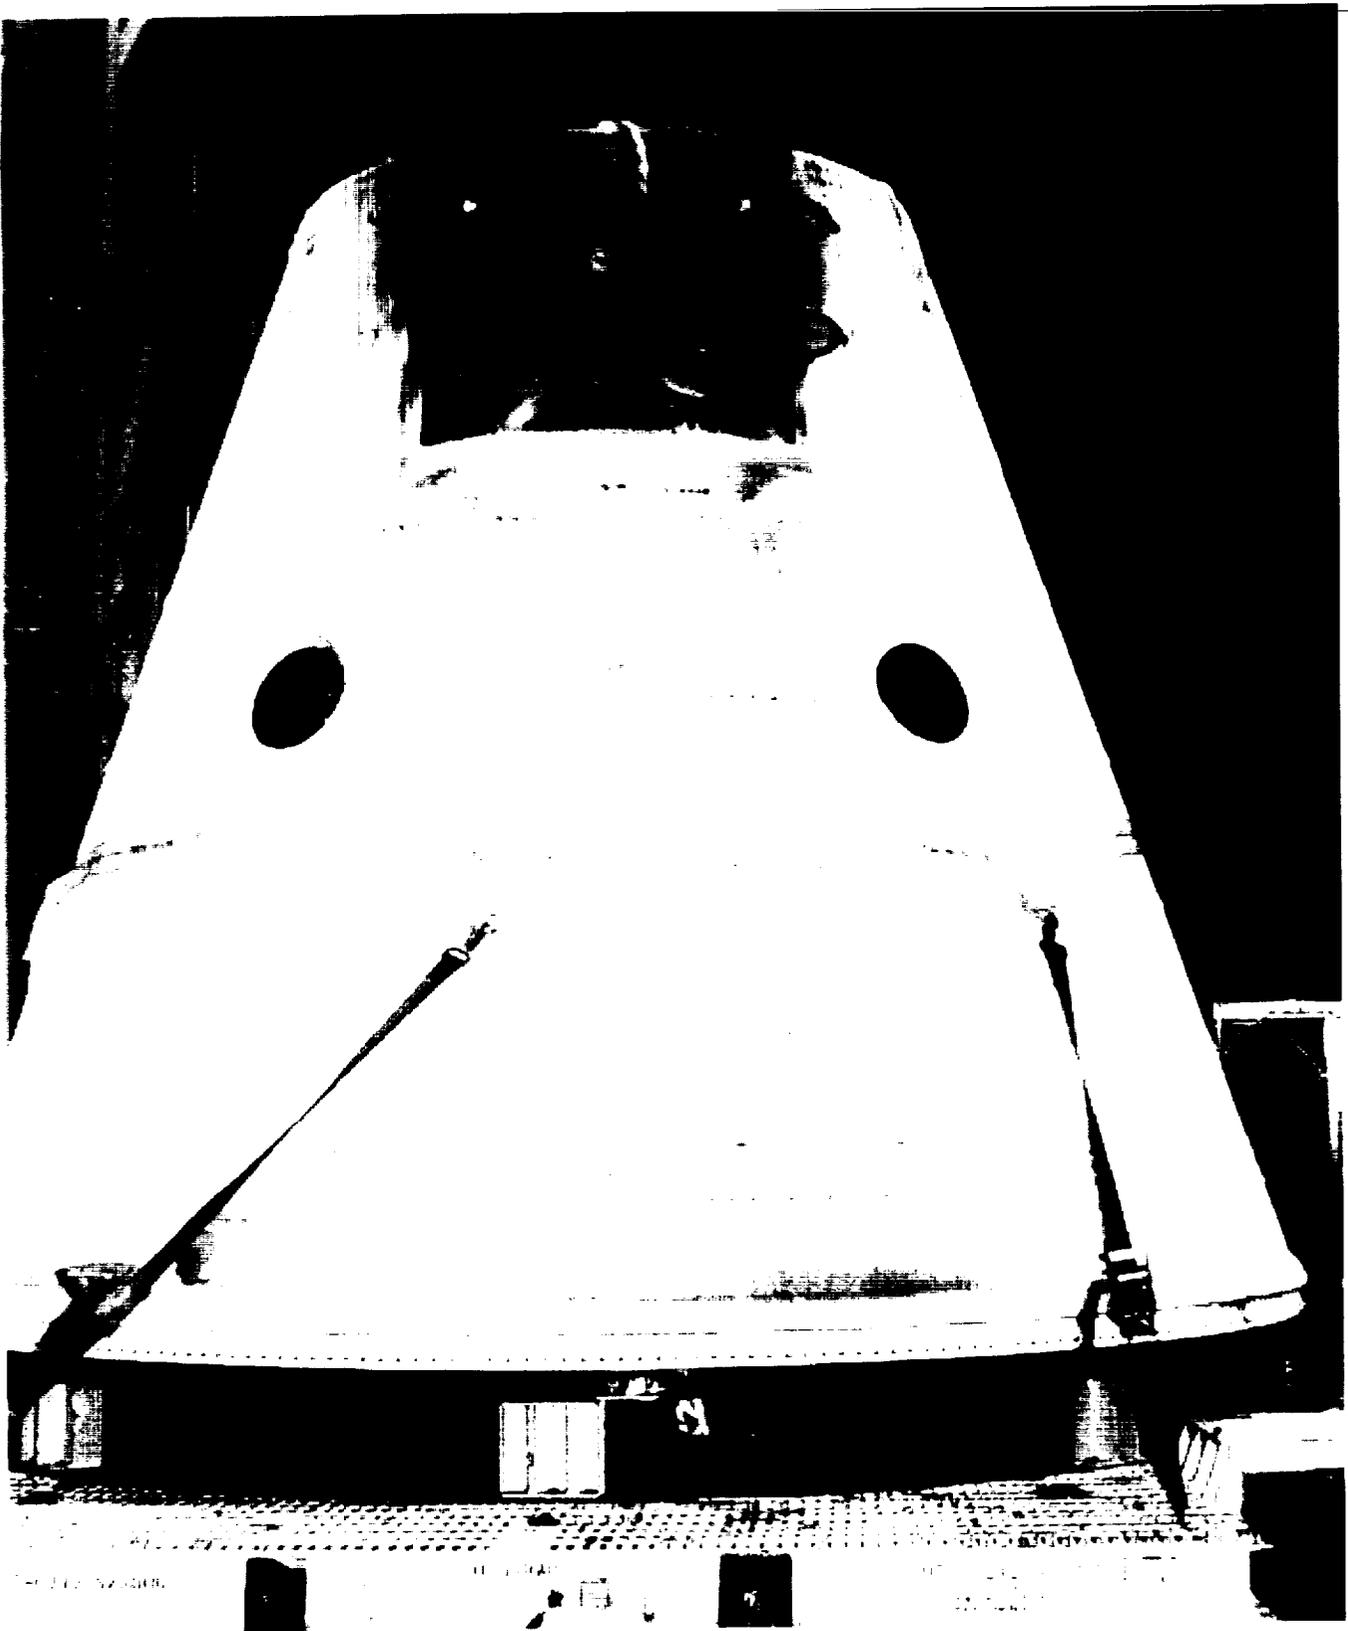
Photo 14: Frustum Post Flight Condition

Both frustums were in excellent condition. No TPS was missing and no debonds/unbonds were detected over fasteners. All eight BSM aero heat shield covers had locked in the fully opened position though the attach ring on the lower left cover of the right frustum had been bent by parachute riser entanglement. Note: a configuration change had been made to the frustums. The PR-1422 sealant/cap closeouts had been eliminated from the majority of the fastener heads prior to the application of ablator. There were no debonds, unbonds, or missing TPS associated with this change.

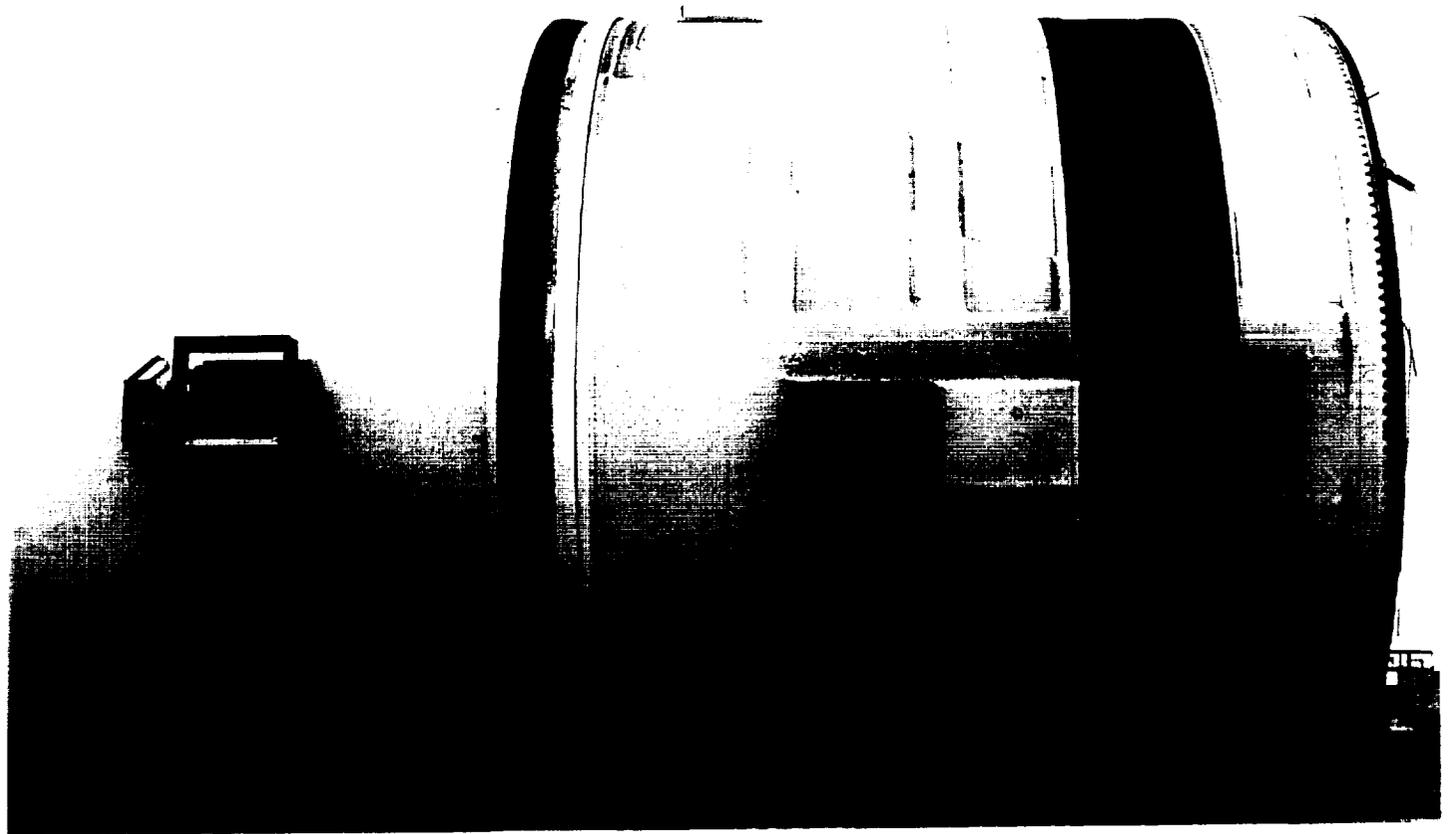
Photo 15: Forward Skirt Post Flight Condition

The forward skirts exhibited no debonds or missing TPS. RSS antennae covers/phenolic base plates were intact. Hypalon paint was blistered/missing over the areas where BTA closeouts had been applied. All frustum severance ring pins and retainer clips were intact.

The forward skirts exhibited no debonds or missing TPS. RSS antennae covers/phenolic base plates were intact. Hypalon paint was blistered/missing over the areas where BTA closeouts had been applied. All frustum severance ring pins and retainer clips were intact. Note water impact damage to the right forward skirt (top photo).

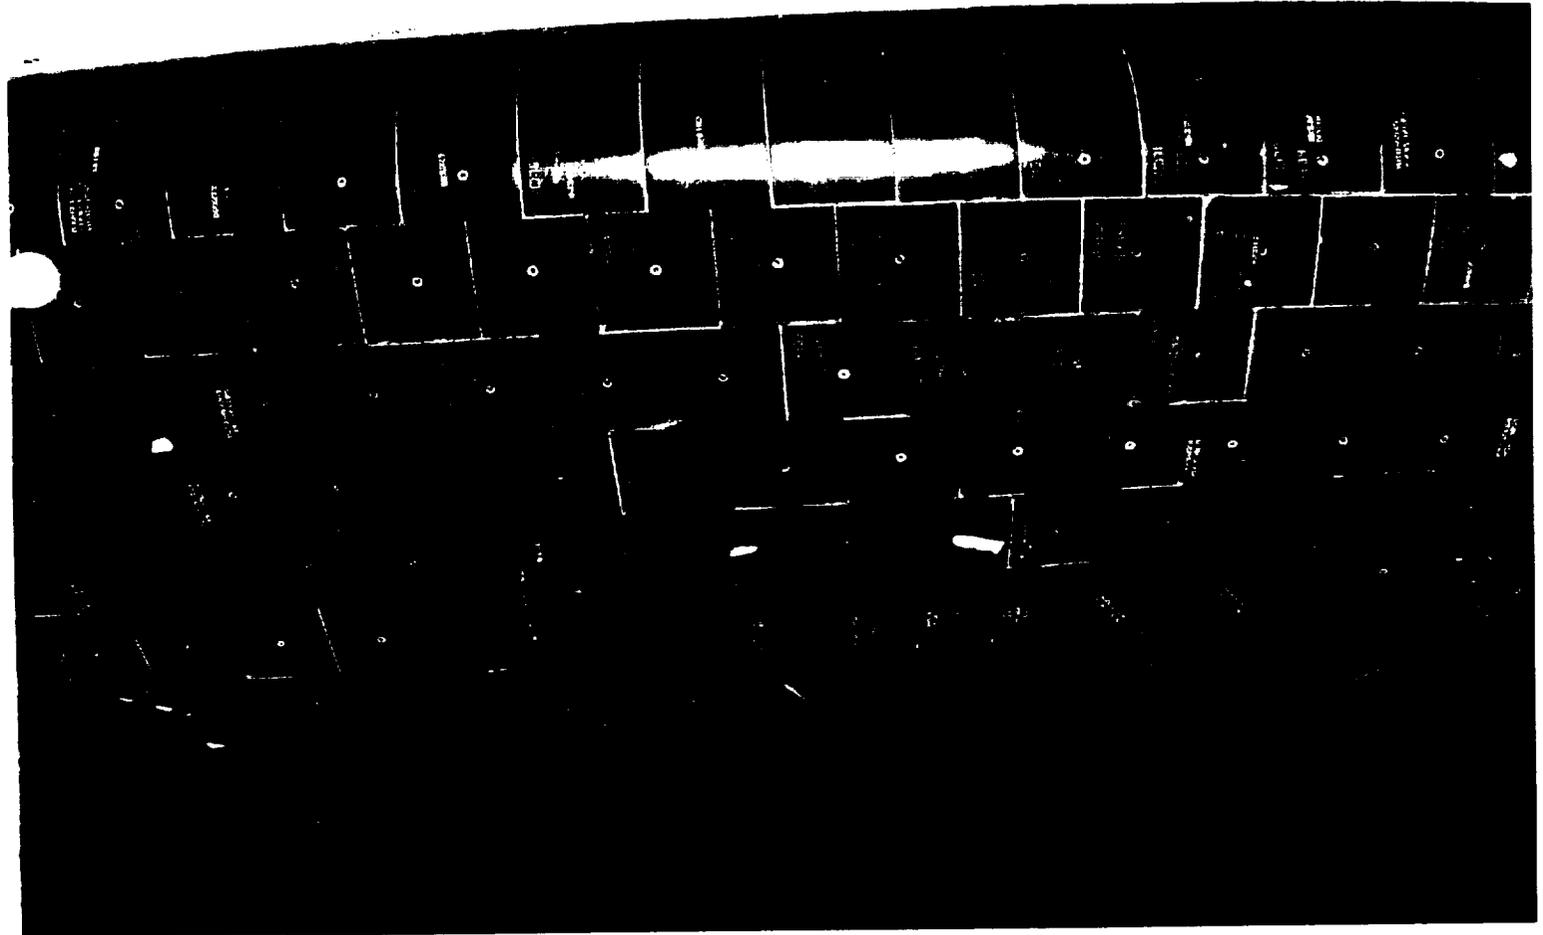
Photo 18: Lower Surface Tile Damage

The Orbiter lower surface sustained 95 total hits, of which 38 had a major dimension of 1-inch or larger. Most of this damage was concentrated near the outboard edges in a line generally running from the nose landing gear to the main landing gear. These damage sites follow the same location pattern documented on STS-86 and STS-87. Although the numbers were greater than the fleet averages for the lower surface, it should be noted that the quantity, sizes, and depths of the damage sites were substantially less than that of STS-87. No lower surface tiles were scrapped due to debris impact damage.

The Orbiter lower surface sustained 95 total hits, of which 38 had a major dimension of 1-inch or larger. Most of this damage was concentrated near the outboard edges in a line generally running from the nose landing gear to the main landing gear. These damage sites follow the same location pattern documented on STS-86 and STS-87. Although the numbers were greater than the fleet averages for the lower surface, it should be noted that the quantity, sizes, and depths of the damage sites were substantially less than that of STS-87

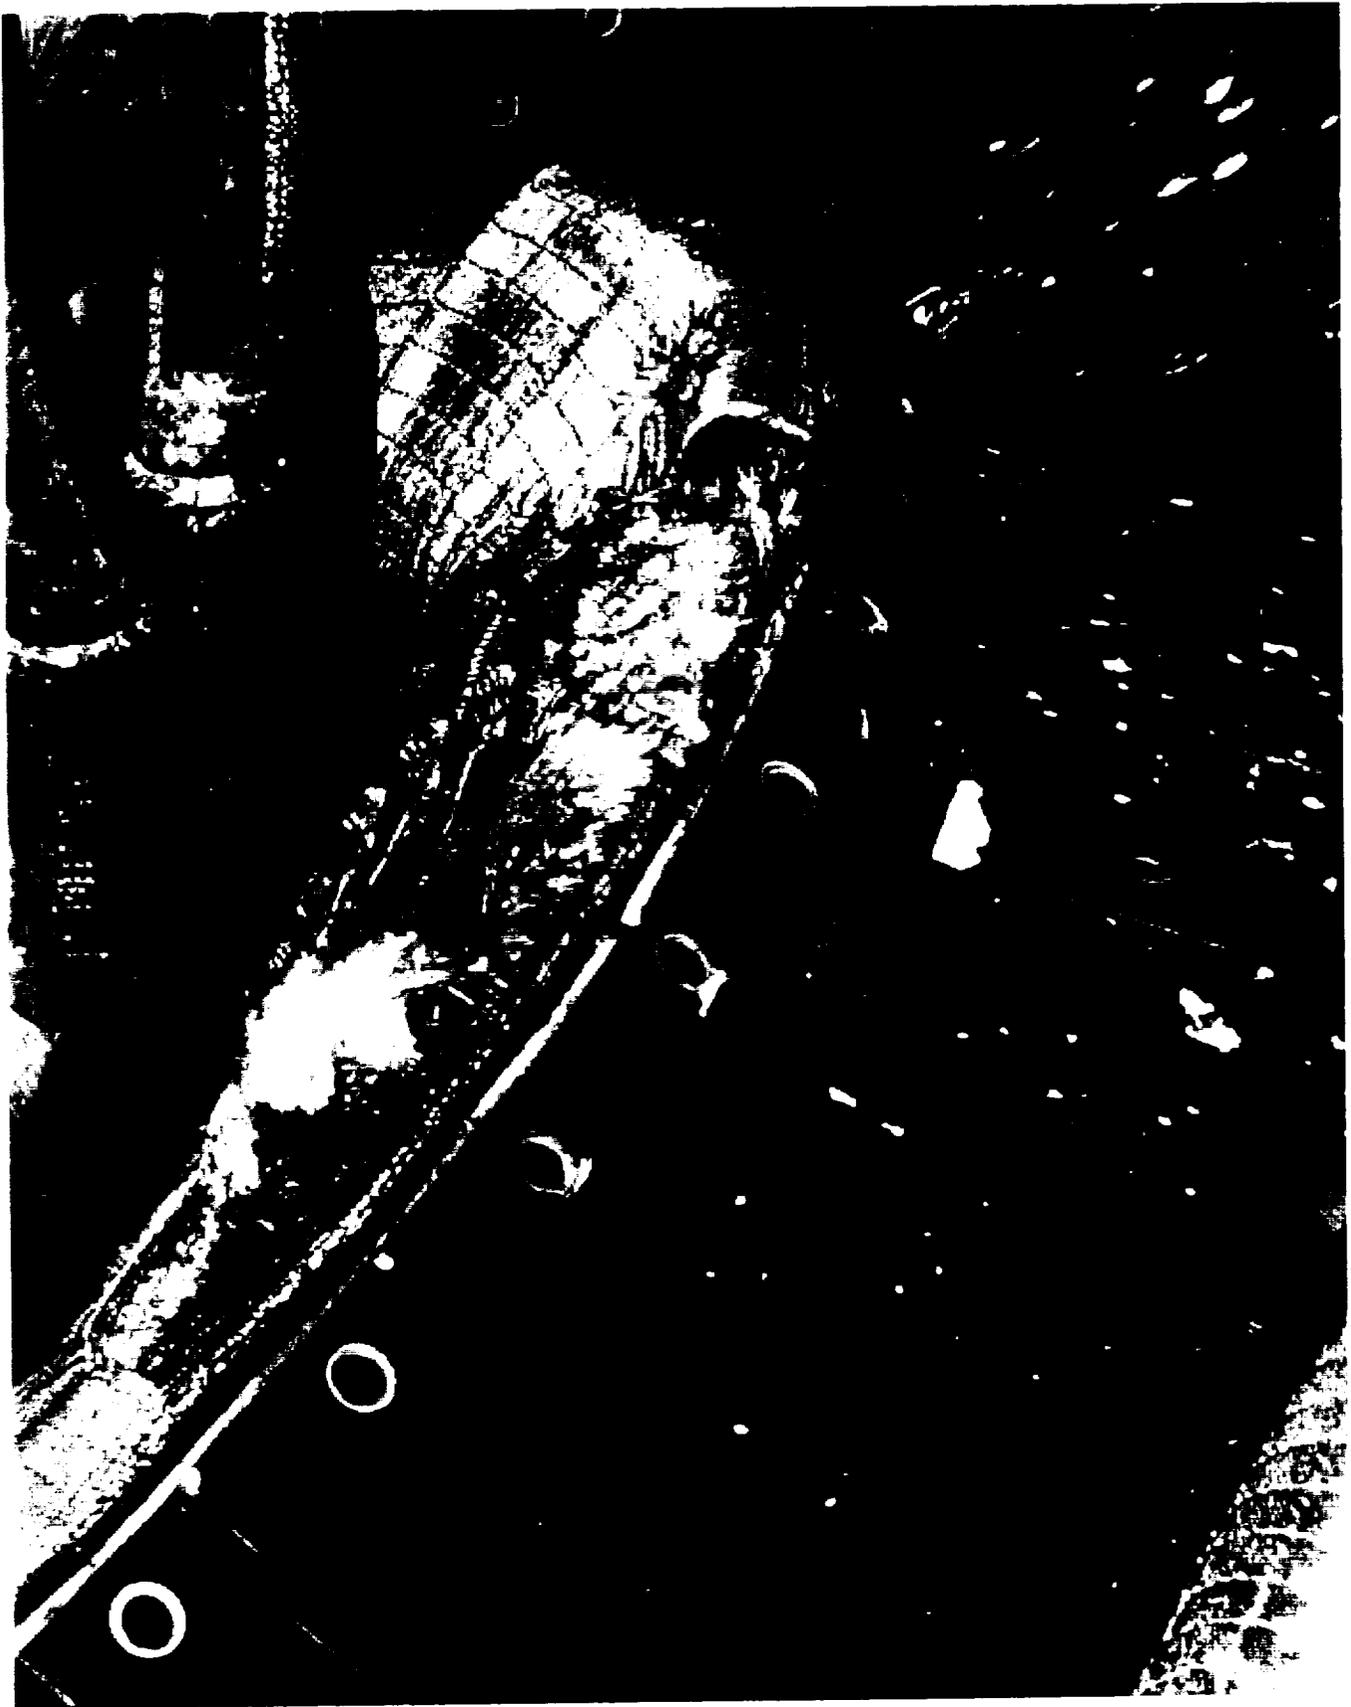
Photo 19: SSME DMHS Closeout Blanket

The SSME #2 and #3 Dome Mounted Heat Shield (DMHS) closeout blankets were in good condition. However, the blanket panels on SSME #1 at the 5:00 and 7:00 o'clock positions were torn/frayed.
